# THE NOL RING TEST

## AN IMPROVED TOOL FOR CHARACTERISING THE MECHANICAL DEGRADATION OF NON-FAILED POLYETHYLENE PIPE HOUSE CONNECTIONS

M. Rozental-Evesque <sup>(1)</sup>, B. Rabaud <sup>(1)</sup>  
M. Sanchez <sup>(2)</sup>, S. Louis <sup>(2)</sup> and C-E. Bruzek <sup>(2)</sup>

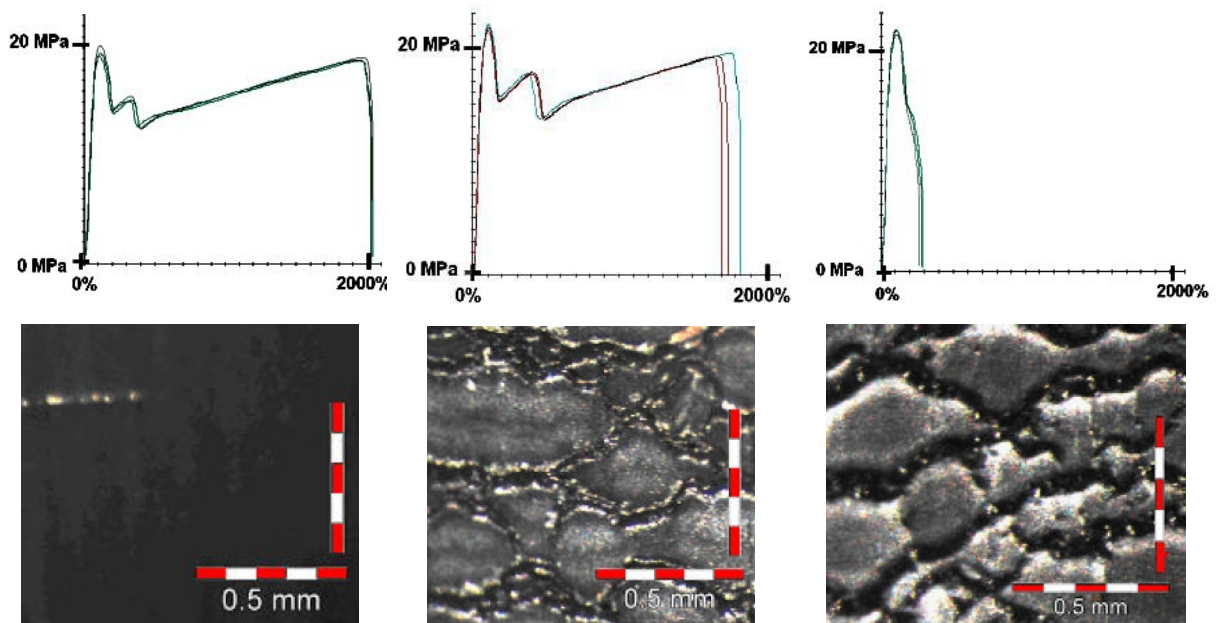
**Figure 3: Nol Ring Tensile Curves and characteristic surface aspect of the specimen inner wall after testing: degradation levels [0], [2] and [4] from left to right**

The brittleness is revealed by a low value of the elongation at break corresponding to scoring and roughness of the inner pipe wall between the stressed areas after testing.

For instance, Figure 3 illustrates the obtained results for 3 of these classified degradation levels.

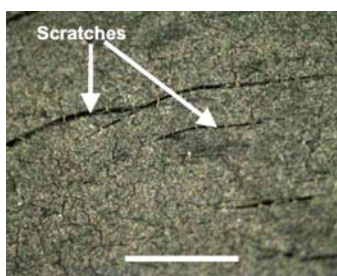
**Figure 6: Cracks in sample surface prior to RBBT**

Field sample N°1 (PE32)

Scale: bar = 1mm

Cracking and micro-cracking can occur together, as may micro-cracking and crazing, as illustrated by the microscopic observations in Figures 6, 7 and 8.

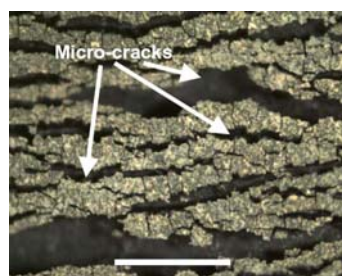
**Figure 7: Typical micro-cracking after RBBT**

Field sample N°1 (PE32).

Scale: bar = 1mm

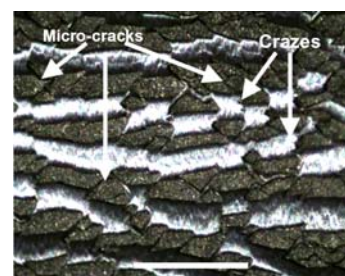
**Figure 8: Typical micro-cracking and crazing after RBBT**

Field sample N°2 (PE32).

Scale: bar = 1mm

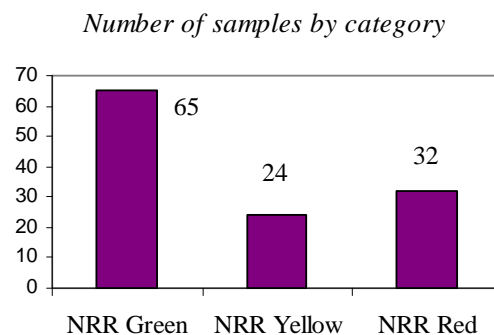
**Figure 9: Sample ranking according to the NRR index**

With this new approach, Figure 9 shows that the classification with the NRR index is more severe than those obtained with the first defined NR degradation categories. Indeed, 20 samples were differently classified (13 samples moved into the Yellow level and 7 other ones into the Red category).

Further investigations were performed for each NRR Index category (Figure 9), taking into account the operating conditions and the disinfection process. Next, the NRR Index was compared to the results obtained from the other degradation indexes.

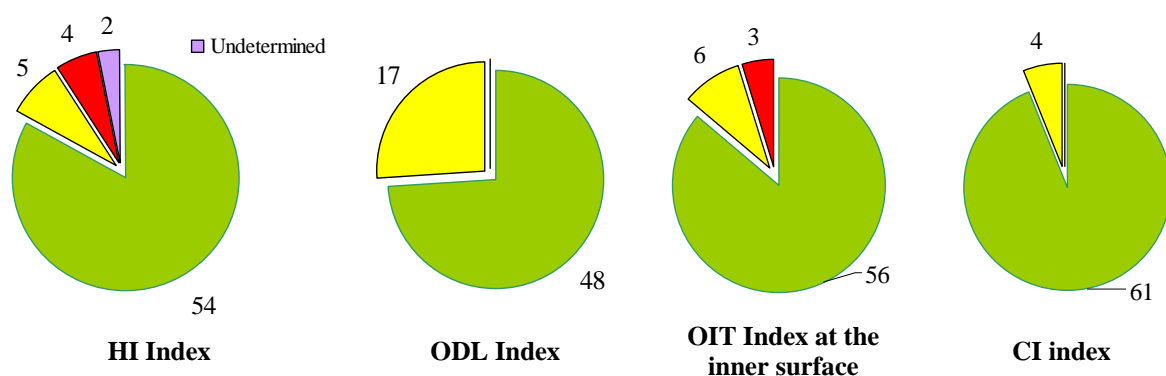
**Figure 10: Comparison between “Green” NRR index and other degradation indexes**

For the Green Degradation Level (NRR Green), no clear differences were noticed between the disinfection processes: 46 samples were exposed to chlorine, 15 to chlorine dioxide, 1 to monochloramines and 3 without any disinfection. Figure 10 illustrates a good correlation between the NRR Index and other indexes. The majority of the samples do not exhibit any oxidation and maintain their mechanical performance.

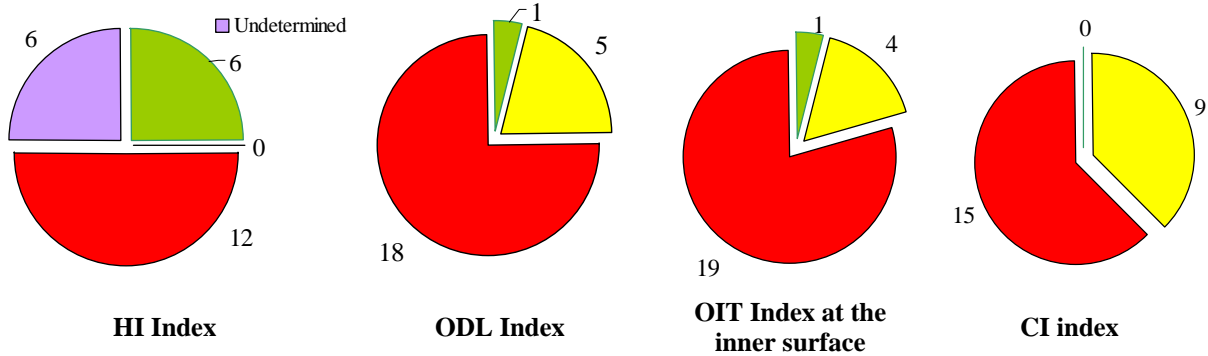
Figure 11: Comparison between the "Red/Red" NRR index and other degradation indexes

A similar connection to the other degradation indexes was observed for the highest degradation category, corresponding to a “Red/Red”<sup>(a)</sup> NRR Index (See Figure 11). Indeed, for those samples, the consumption of antioxidant was complete at the inner wall, combined with a high oxidation level leading to an embrittlement of the inner surface. In addition, about 2/3 of the samples showed a poor hydrostatic HI index, i.e. poor pressure resistance.

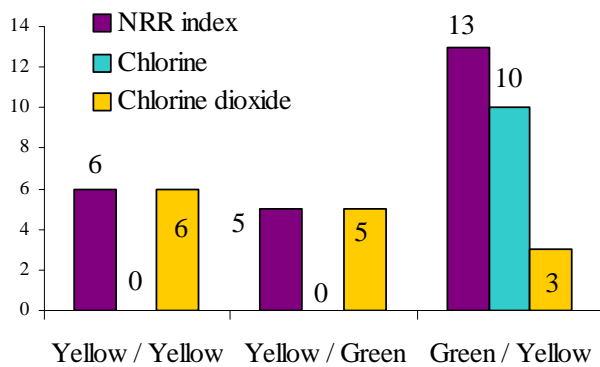
Figure 12: Moderated Degradation Level  
Distribution according to disinfectant type

Yellow NRR Index: [Aspect] / A% classification

Regarding to the disinfection process (See Figures 12 and 13), the Red/Red NRR Category corresponds mainly to PE pipes exposed to chlorine dioxide-disinfected water. The remaining 8 samples with chlorine correspond to the oldest specimens (30 years old) in Northern Africa and Southern Europe, where water temperature is high. For the yellow/yellow NRR class, all 6 of the samples were also disinfected by chlorine dioxide.

- "Yellow" specimen appearance/"Green" A% value, or a "Red"/"Yellow" combination, respectively(b): 6 samples were identified, as illustrated in Figures 12 and 13.
- "Green" specimen appearance combined with a "Red" or "Yellow" elongation at break value(c). This combination is exhibited by 20 samples.

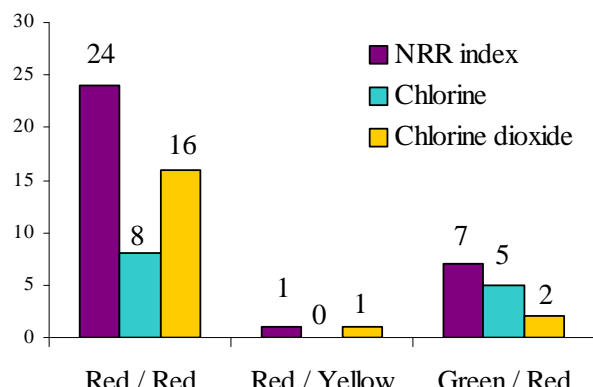
Figure 13: High Degradation Level  
Distribution according to disinfectant type

Red NRR Index: [Aspect] & A% Classification

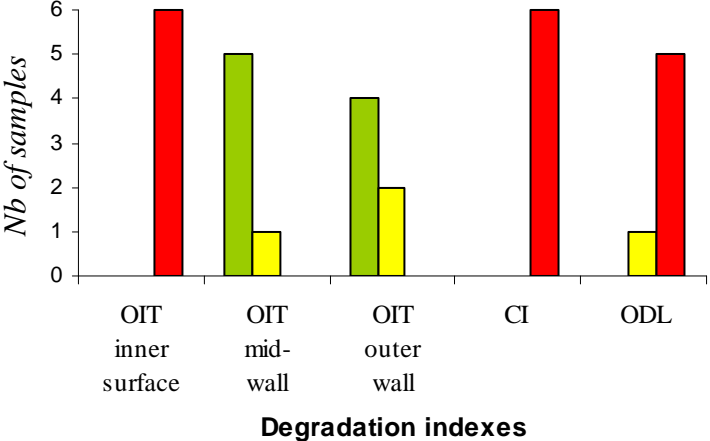
Figure 14: Yellow/Green and Red/Yellow classes for Nol Ring [Aspect] and A% value

Firstly, Figure 14 demonstrates that all these samples are chemically oxidised. The depletion of antioxidants was focused on the inner wall, without any consumption in the mid-wall and outer wall. The presence of oxidation products and an embrittlement of the inner pipe wall were also noticed. Thus, this category of samples maintains a good or a moderate mechanical resistance even if the chemical oxidation process has already started.

Figures 14 and 15 detail the results obtained with the other degradation indexes for both classes of samples.

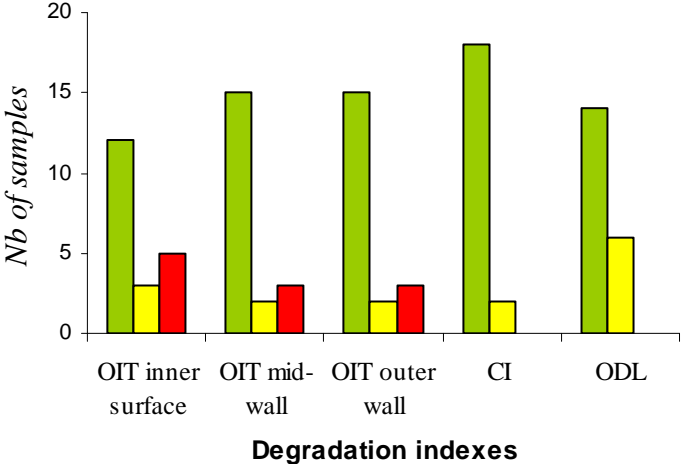
Figure 15: Green/Yellow and Green/Red classes for Nol Ring [Aspect] and A% value

At the opposite end, Figure 15 clearly indicates another phenomenon for pipe degradation. In this case, the “Green” level classification of all OIT, CI and ODL indexes refers to poor quality materials rather than samples oxidised by chemical ageing.
